# **INDOOR AIR QUALITY ASSESSMENT**

**Field Elementary School  
99 School Street  
Weston, Massachusetts 02493**

Prepared by:  
Massachusetts Department of Public Health  
Center for Environmental Health  
Emergency Response/Indoor Air Quality Program  
December 2005

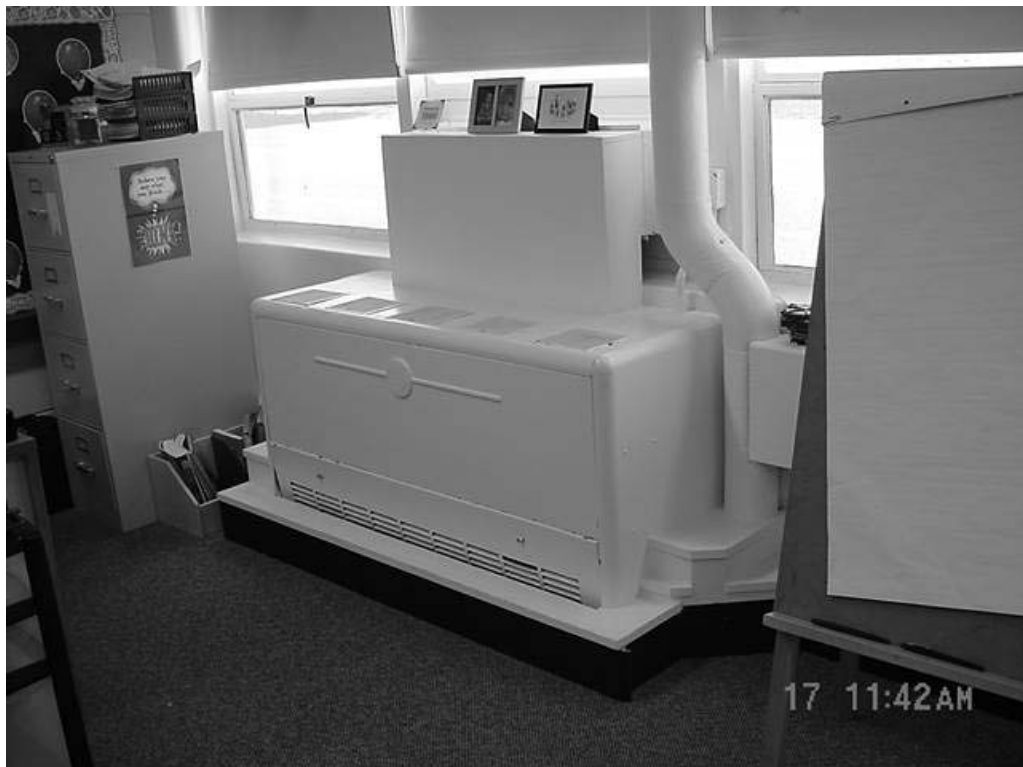
**Picture 1**

**Classroom Univent 1950's Vintage**

1. Examine each univent for function. Survey classrooms for univent function to ascertain if an adequate air supply exists for each room. Continue with plans to repair univent in classroom 9. Consider consulting a heating, ventilation and air conditioning (HVAC)

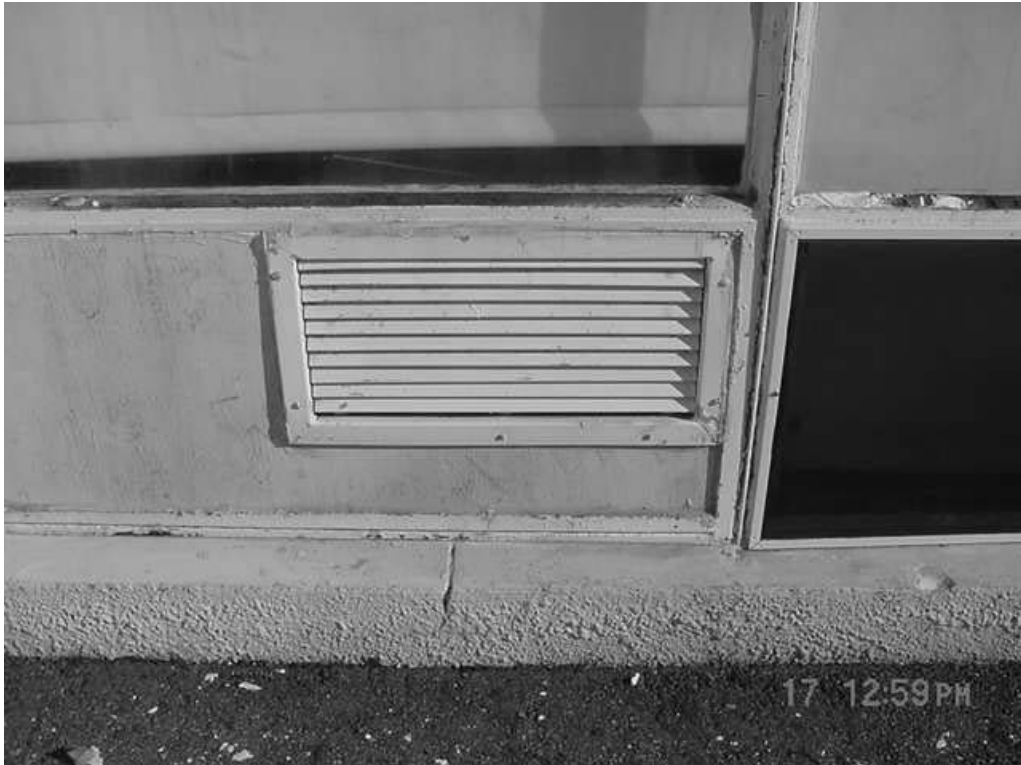
**Picture 2**

**Univent Fresh Air Intake**

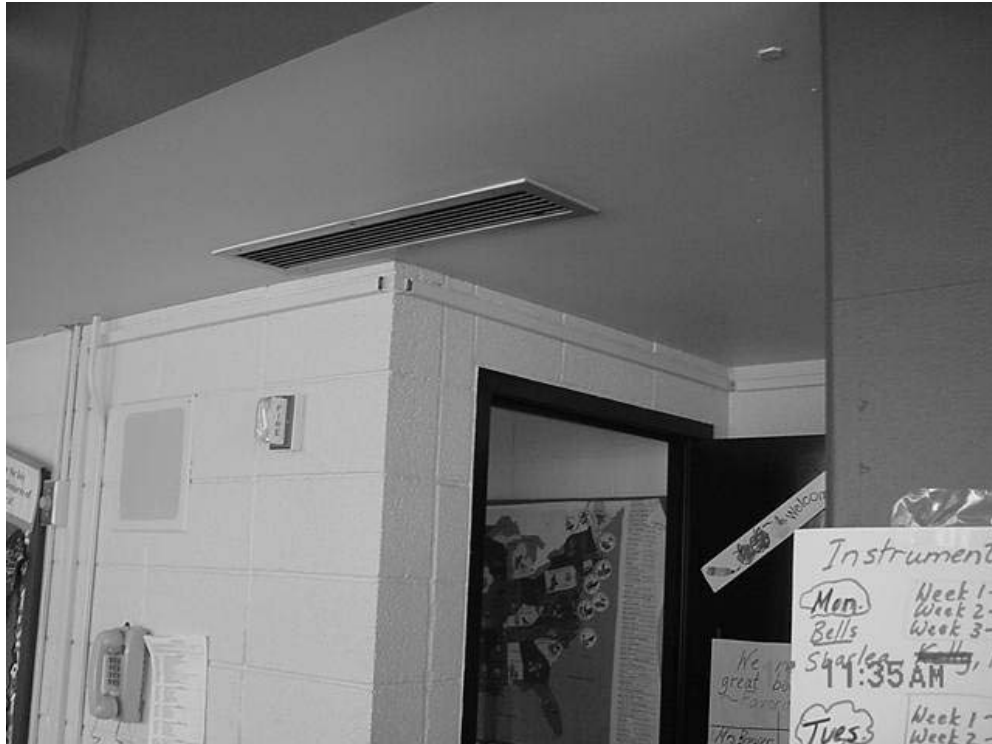
Picture 3

Exhaust ventilation in classrooms is provided by ducted, grated wall or ceiling vents (Pictures 3 and 4) powered by rooftop motors. Several rooftop exhaust vents were also reported to be on order to be repaired; therefore no means of mechanical exhaust for these classrooms was being provided during the assessment. A number of exhaust vents were also obstructed by desks, bookcases and other items (Picture 4). As with the univents, in order to function properly, exhaust vents must be activated and remain free of obstructions. In addition, the location of some exhaust vents can limit exhaust efficiency. In several rooms, exhaust vents are located near hallway doors. When these classroom doors are open, exhaust vents become blocked (Picture 5). Exhaust vents in these rooms will also tend to draw air from both the hallway and the classroom, reducing the effectiveness of the exhaust vent to remove common environmental pollutants.

**Ceiling-Mounted Exhaust Vent**

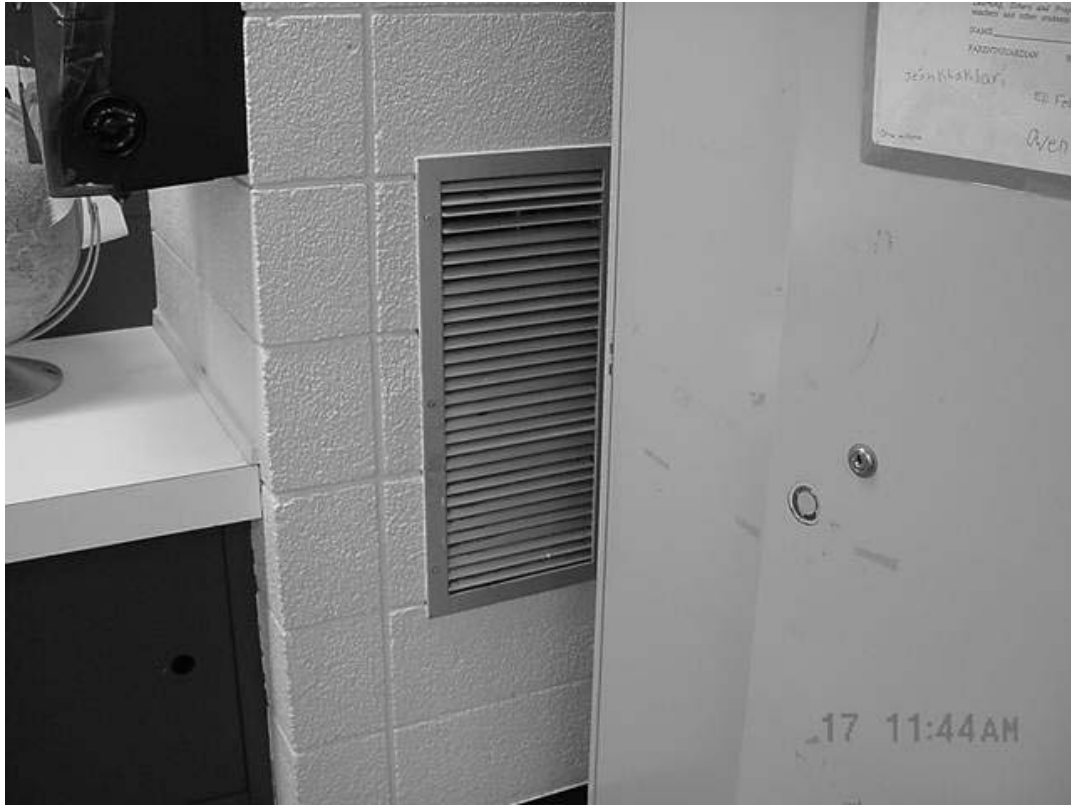
**Picture 4**

**Wall-Mounted Exhaust Vent Partially Obstructed by Cabinet**

3. Inspect exhaust motors and belts for proper function. Continue with plans to repair and replace as necessary.
4. Remove all blockages from univents and exhaust vents to ensure adequate airflow.

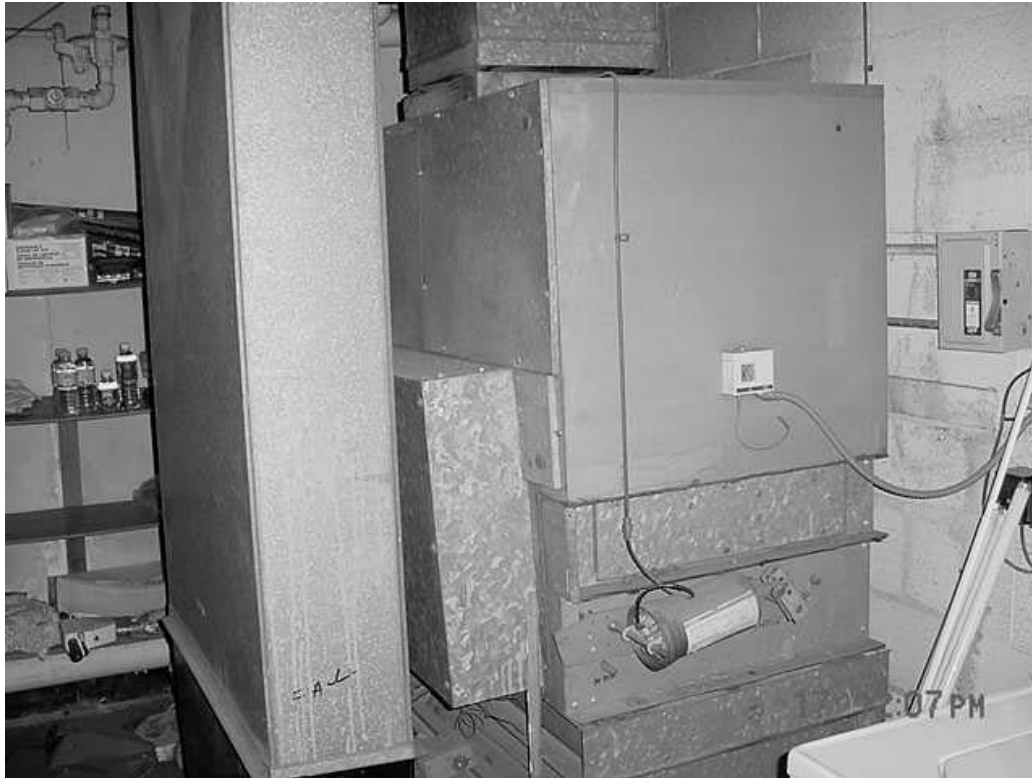
**Picture 6**

Mechanical ventilation for the computer room is provided by an air handling unit (AHU) located in a mechanical room. Supply air is ducted to the room via wall-mounted vents and ducted back to the AHU through wall-mounted return vents. This system was operating during the assessment.

**Air Handling Unit for Computer Room**

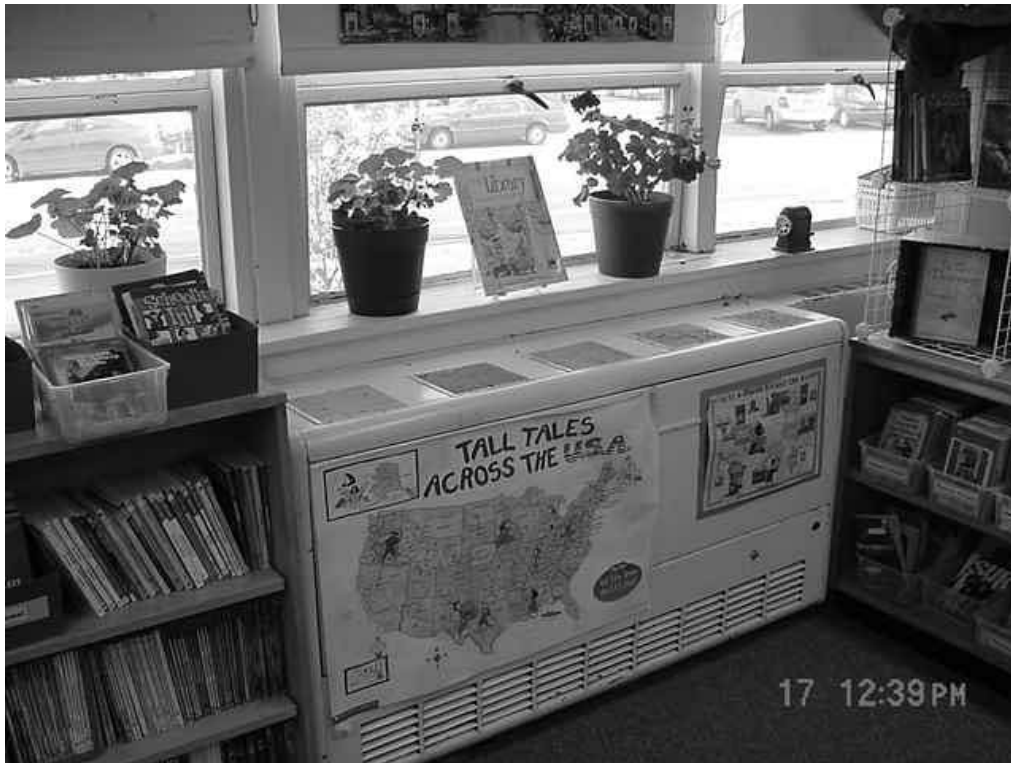
**Picture 7**

Several classrooms contained a number of plants. Plants, soil and drip pans can serve as sources of mold growth, and thus should be properly maintained. Plants should have drip pans to prevent wetting and subsequent mold colonization of window frames. Plants should also be located away from ventilation sources to prevent aerosolization of dirt, pollen or mold (Picture 7).

**Flowering Plants near the Air Stream of Univent Air Diffuser**

7. Repair cracks/breaches in foundation to prevent water penetration, drafts and pest entry.
8. Move plants away from univents in classrooms. Avoid over-watering and examine drip pans periodically for mold growth. Disinfect with an appropriate antimicrobial where necessary.

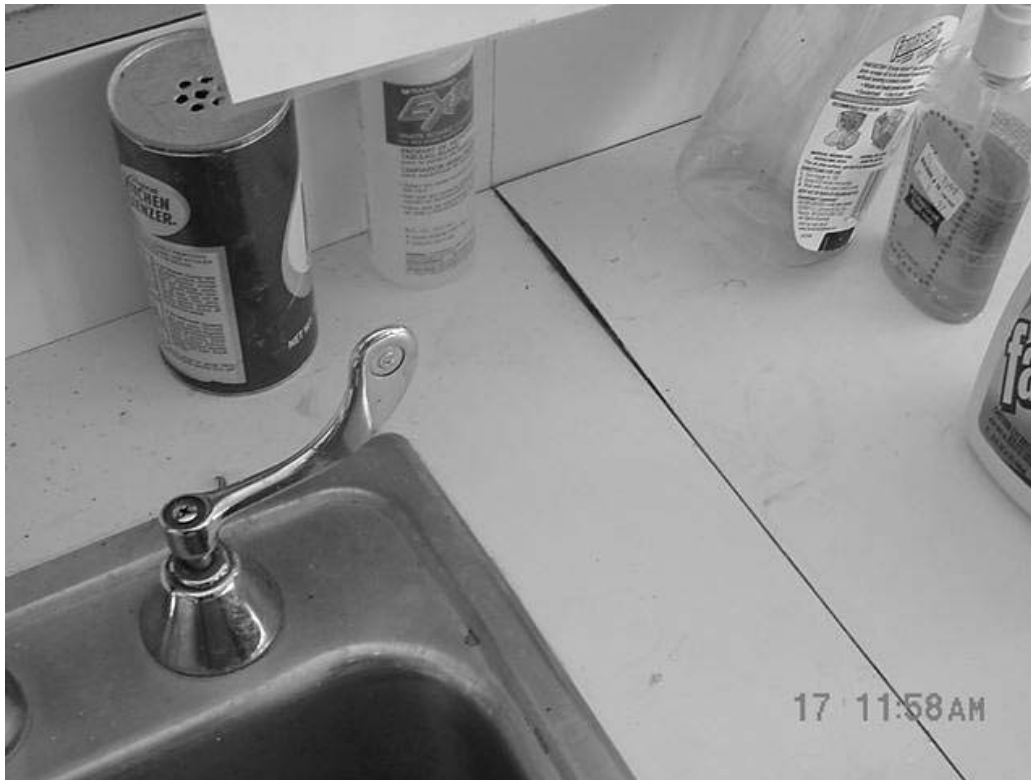
**Picture 8**

Spaces between the sink countertop and backsplash were also seen in a few classrooms (Picture 8). Improper drainage or sink overflow can lead to water penetration into countertop wood, the cabinet interior and areas behind cabinets. If these materials become wet repeatedly they can provide a medium for mold growth.

**Breach in Sink Countertop**

- appropriate antimicrobial where necessary. Consider installing wire mesh to prevent further roosting.
10. Seal/repair sink countertops to prevent water seepage. Observe countertops and interior of cabinets for water-damage and mold growth. Disinfect with an appropriate antimicrobial where necessary.

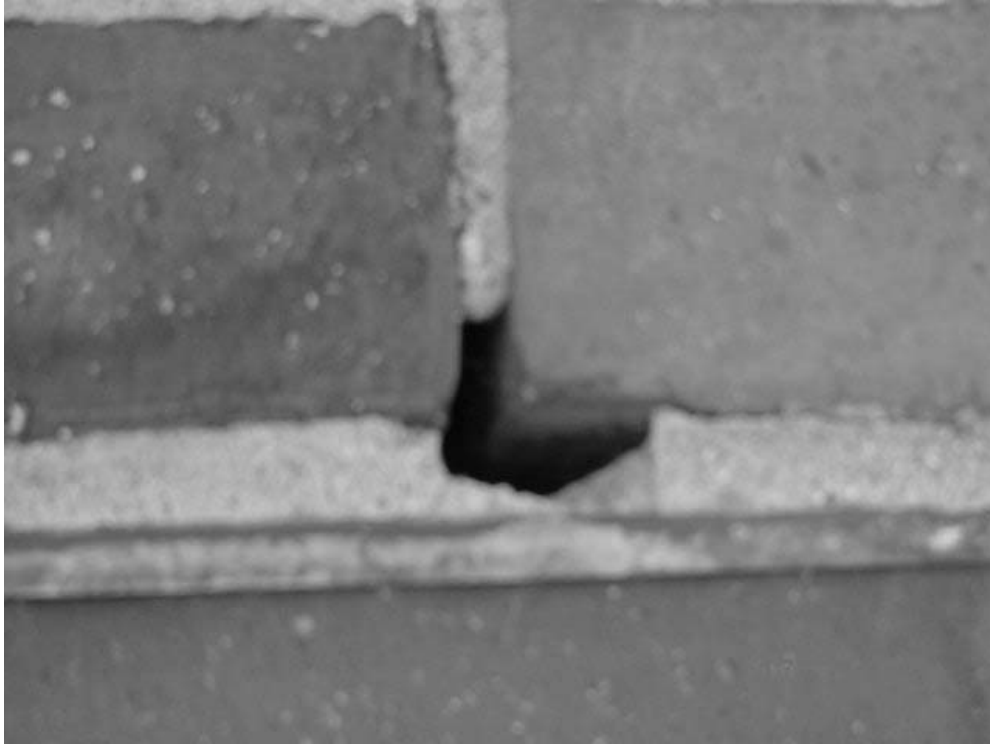
**Picture 9**

The exterior of the building was examined for potential pathways for water penetration. MDPH staff observed open utility holes in exterior walls (Picture 9) and a large crack in

**Missing/Damaged Mortar around Brickwork**

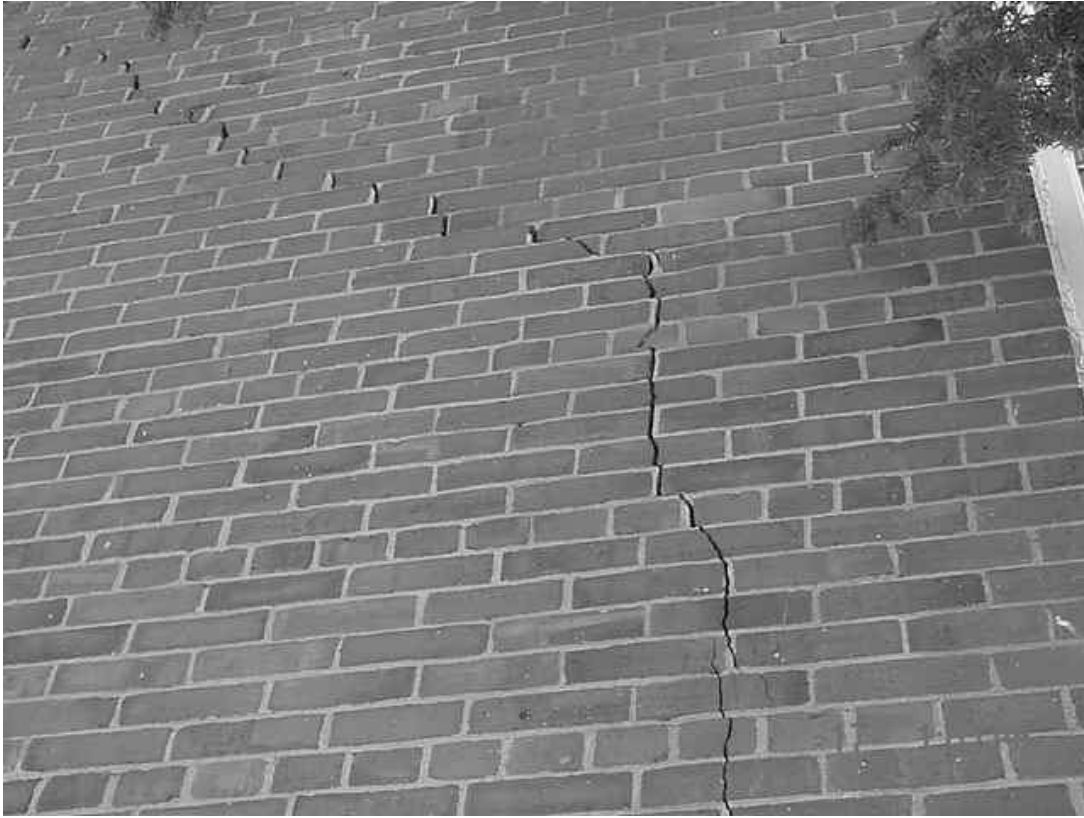
**Picture 10**

brickwork along the front of the building (Picture 10). Repeated water penetration can result in the chronic wetting of building materials and potentially lead to microbial growth. In addition, these large cracks/holes in the exterior wall may provide a means of egress for pests/rodents into the building.

**Large Wall Crack along Front of Building**

1. Replace/repair window systems building-wide to prevent water penetration and drafts through window frames. Consider re-pointing and waterproofing exterior brickwork to prevent water intrusion. Weatherproofing materials should be applied during periods when the school is not occupied.
2. Contact an HVAC engineering firm for an assessment of the ventilation system's control system (e.g., controls, air intake louvers, thermostats). Based on the age, physical deterioration and availability of parts for ventilation components, such an evaluation is necessary to determine the operability and feasibility of repairing/replacing the equipment.
3. Consider providing local exhaust ventilation for photocopiers.

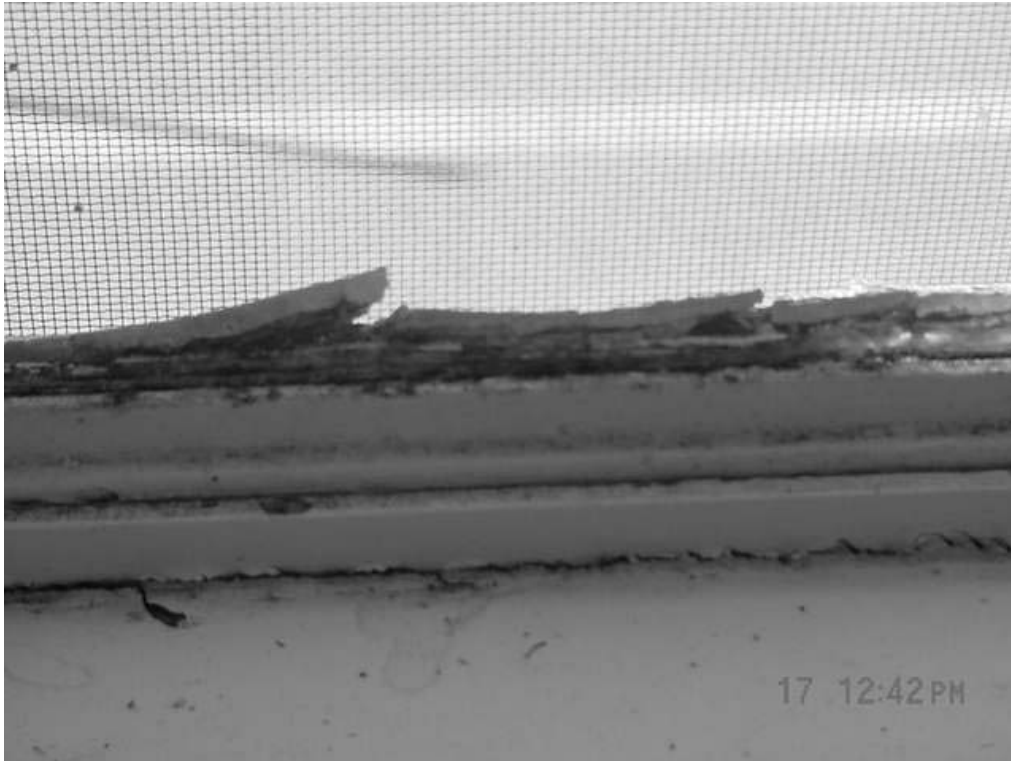
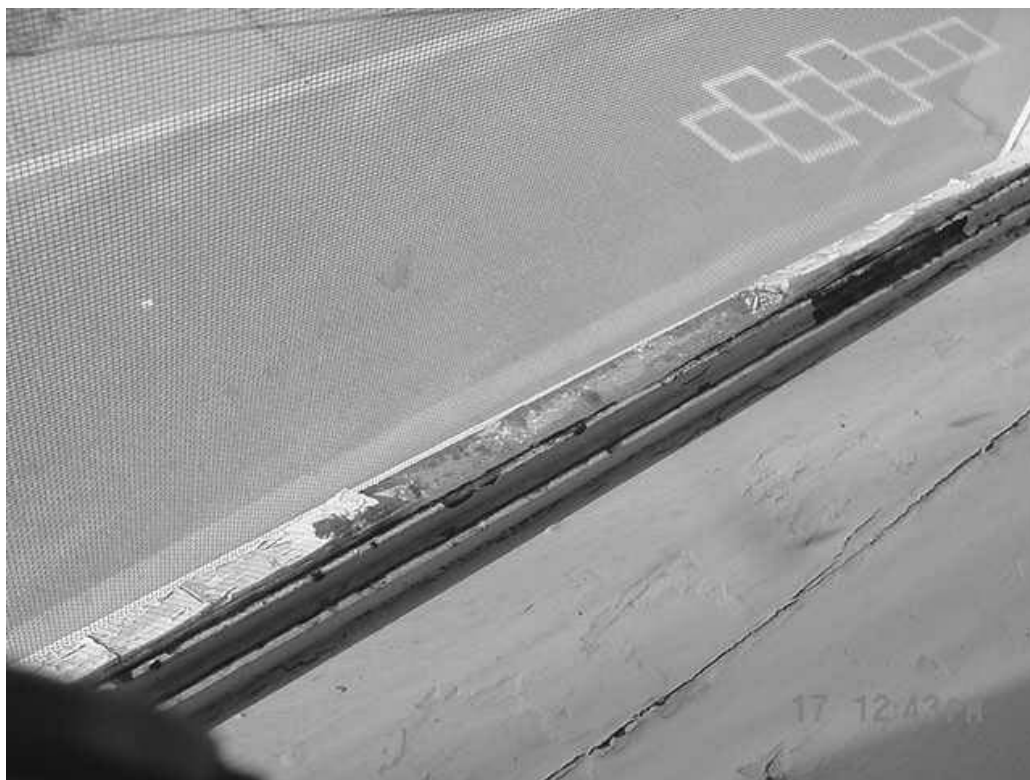
Although exterior window caulking was replaced in some areas, caulking around windows and frames in the remaining areas of the building was crumbling/damaged indicating that the water seal is no longer intact (Pictures 11 through 13). Replacement of caulking and repairs of window leaks are necessary to prevent water penetration and subsequent damage to building materials, which can lead to mold growth.

**Missing/Damaged Window Caulking**

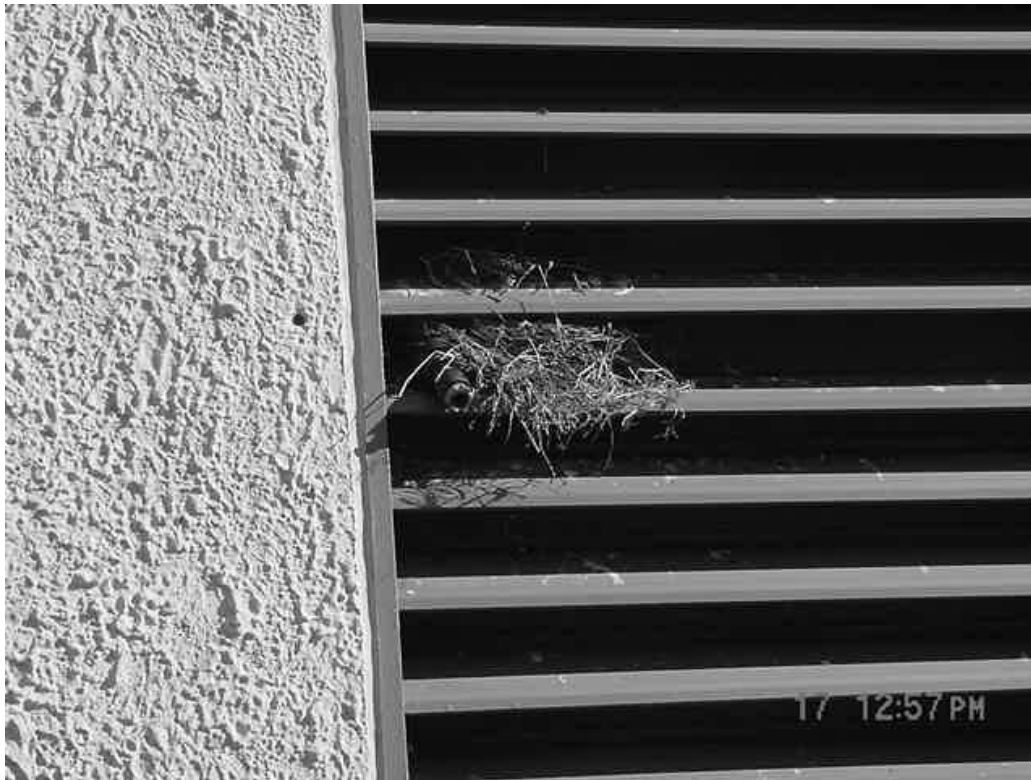
**Picture 14**

Finally, a bird's nest was observed between fresh air intake louvers of the gymnasium AHU (Picture 14). At the time of the assessment, MDPH staff recommended removing the nest and disinfecting the intake louvers using an antimicrobial agent. Birds can be a source of disease, and bird wastes and feathers can contain mold and mildew, which can be irritating to the respiratory system. No obvious signs of bird roosting inside the building were noted by MDPH staff nor were such signs reported by occupants.

**Birds Nest in Intake Louvers for Gymnasium AHU**

9. Ensure bird’s nest is removed from air intake (Picture 14). Inspect to ensure surfaces are free of nesting materials and bird wastes. Clean and disinfect intake vents with an

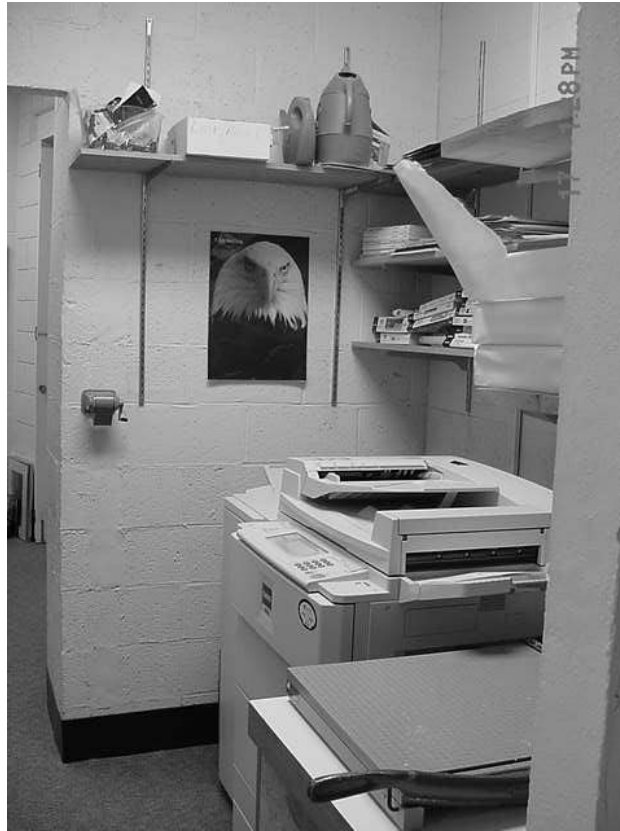
**Picture 15**

The main office contained a photocopier, which can produce irritating odors during use (Picture 15). VOCs and ozone can be produced by photocopiers, particularly if the equipment is

older and in frequent use. Ozone is a respiratory irritant (Schmidt Etkin, 1992). This area is not equipped with local exhaust ventilation to help reduce excess heat and odors.

**Photocopier in Alcove of Main Office**

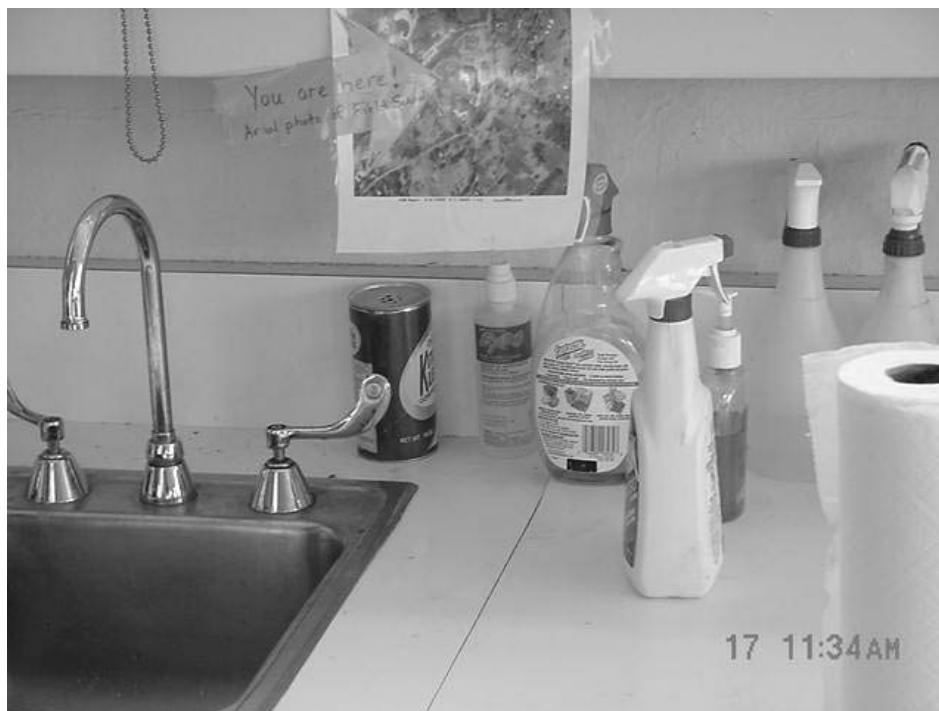
**Picture 16**

Cleaning products were found beneath sinks and on counter tops in classrooms (Picture 16). Cleaning products contain chemicals (such as bleach or ammonia-related compounds), which can be irritating to the eyes, nose and throat. These items should be stored properly and out of the reach of students.

**Spray Cleaning Products on Classroom Countertop**

15. Store cleaning products properly and out of reach of students.
  16. Consider adopting the US EPA (2000b) document, "Tools for Schools", to maintain a good indoor air quality environment on the building. This document can be downloaded from the Internet at: <http://www.epa.gov/iaq/schools/index.html>.

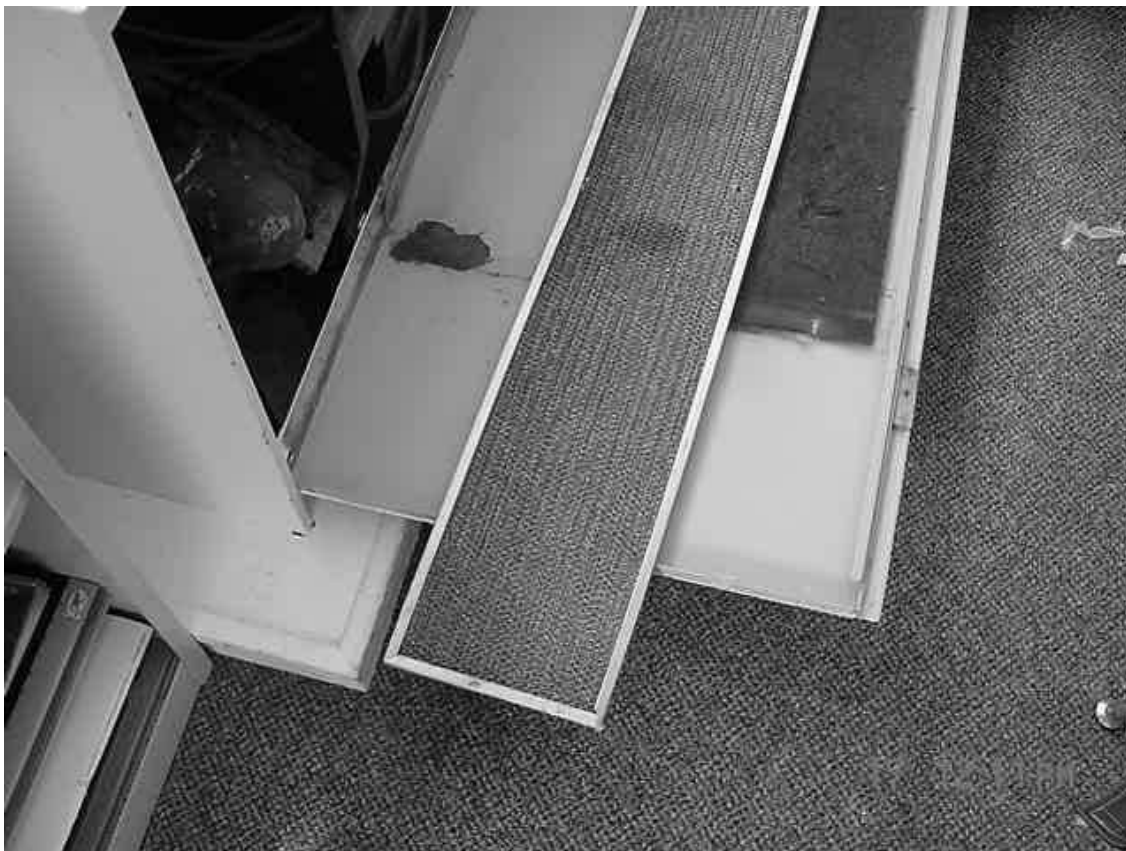
**Picture 17**

Finally, several classroom univents contained metal/mesh filters (Picture 16). The material used for filter media provides minimal filtration of respirable particulates. In order to decrease aerosolized particulates, disposable filters with an increased dust spot efficiency can be installed in these units. The dust spot efficiency is the ability of a filter to remove particulates of a certain diameter from air passing through the filter. Filters that have been determined by ASHRAE to meet its standard for a dust spot efficiency of a minimum of 40 percent would be sufficient to reduce airborne particulates (Thornburg, 2000; MEHRC, 1997; ASHRAE, 1992). Note that increased filtration can reduce airflow produced by the unit by increased resistance

(called pressure drop). Prior to any increase of filtration, each piece of air handling equipment should be evaluated by a ventilation engineer to ascertain whether they can maintain function with more efficient filters. The age and function of some univents may preclude any attempt to increase filter efficiency.

**Metal/Mesh Filter in Classroom Univent**

12. Consider upgrading filters in univents to disposable filters with a higher dust spot efficiency.
  13. Clean/change filters for portable air purifiers as per the manufacturer's instructions or more frequently if needed.
